## **Hyperion Treatment Plant**

ROV Inspection

## **One-Mile Diversion Chambers**

Report Date: October 25, 2021

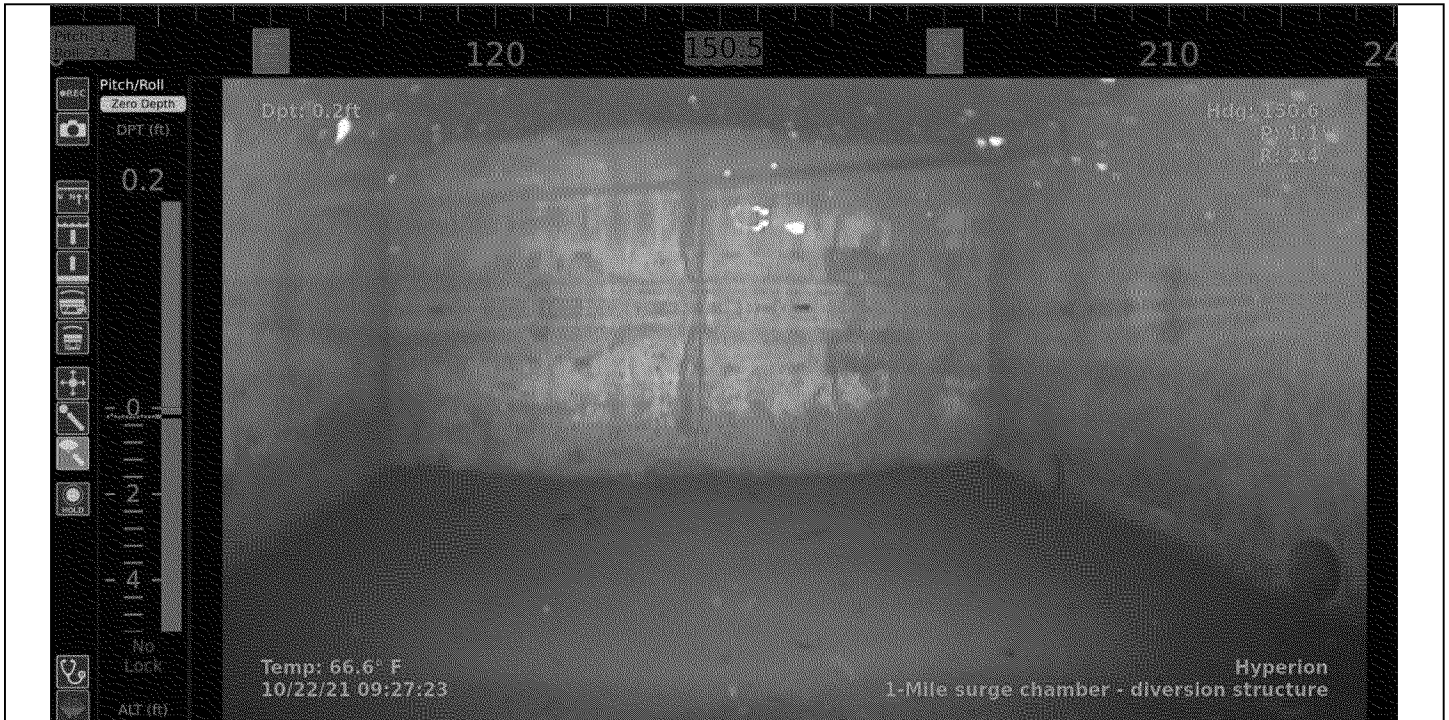
Photo #2: East diversion structure below water line

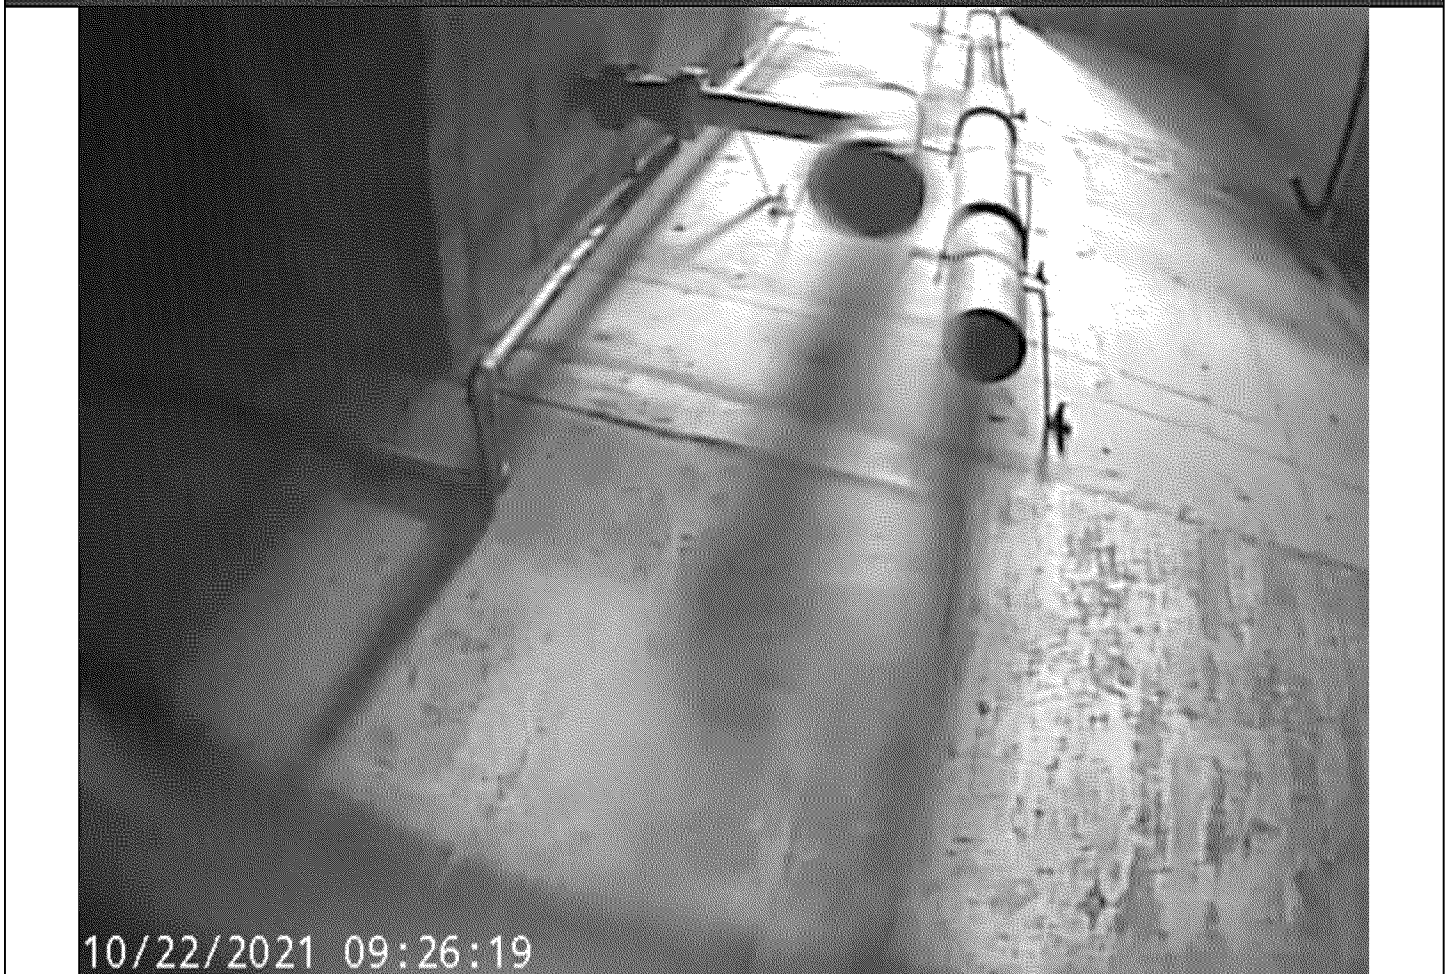
Photo #3: East diversion structure piping above water on Northwest wall

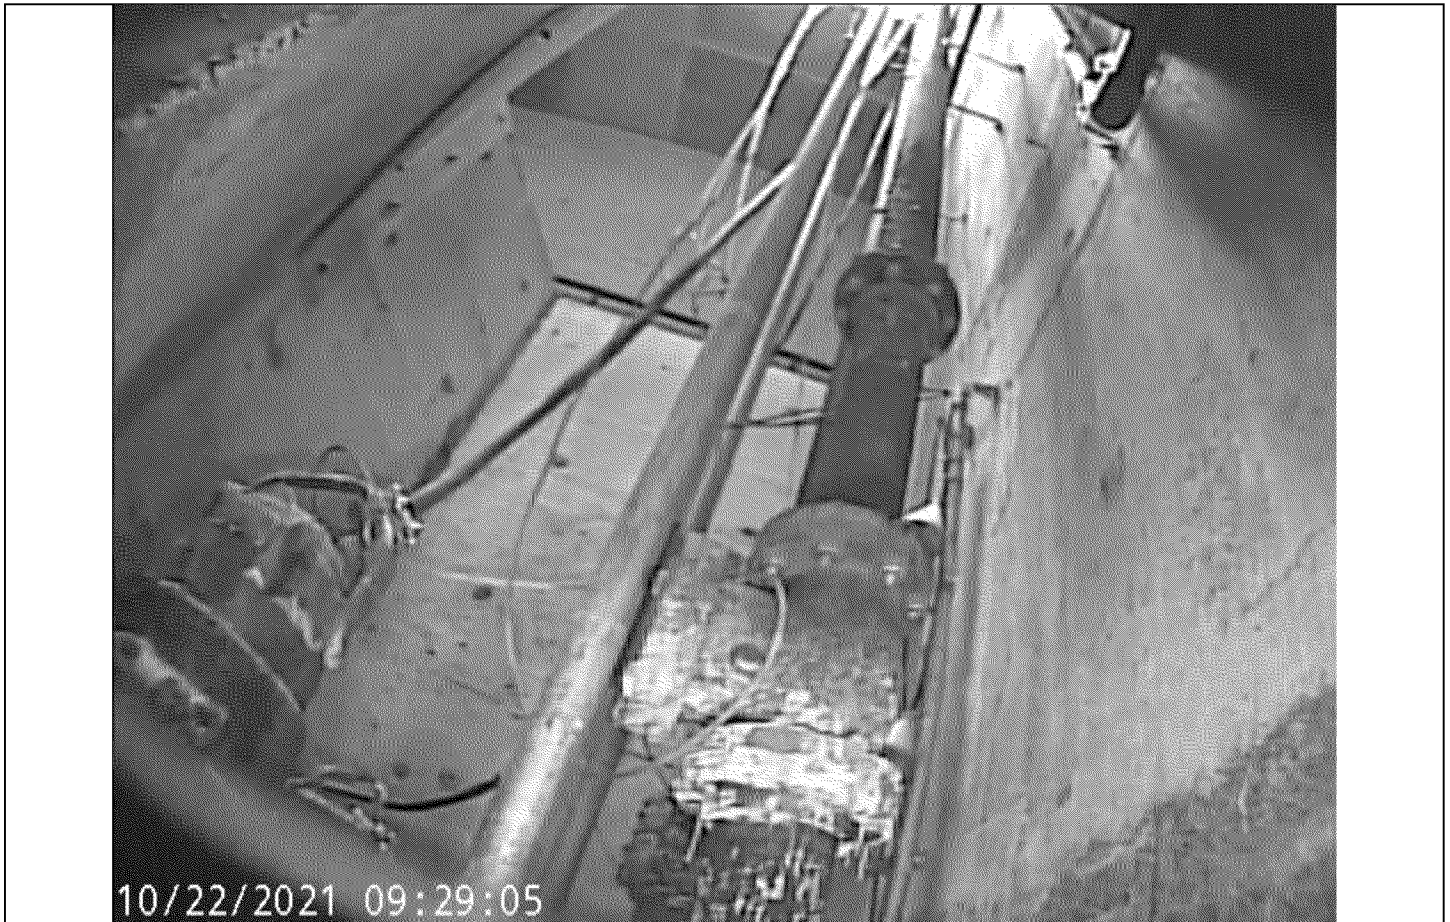
Photo #4: East diversion structure piping in southwest corner

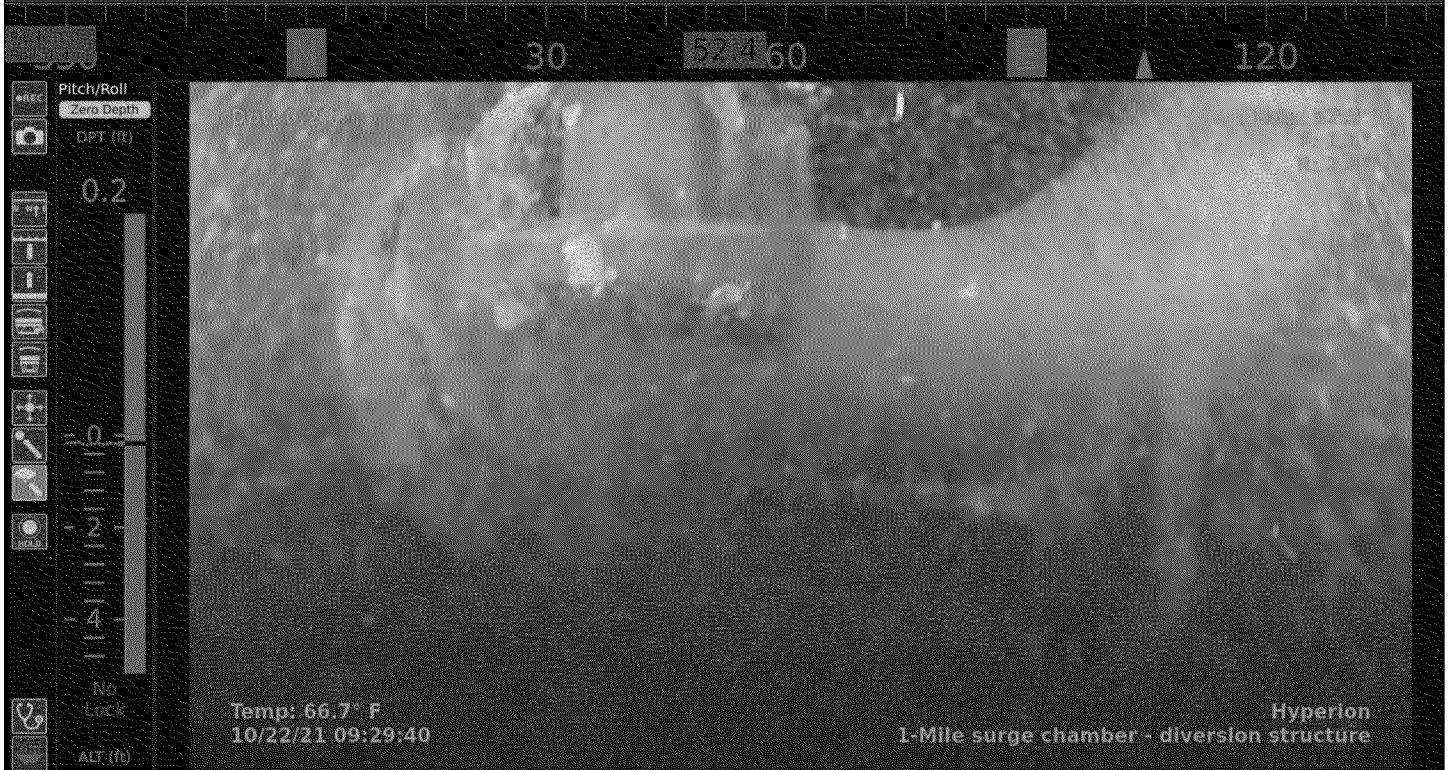
Photo #5: East diversion structure piping in southwest corner below the water line

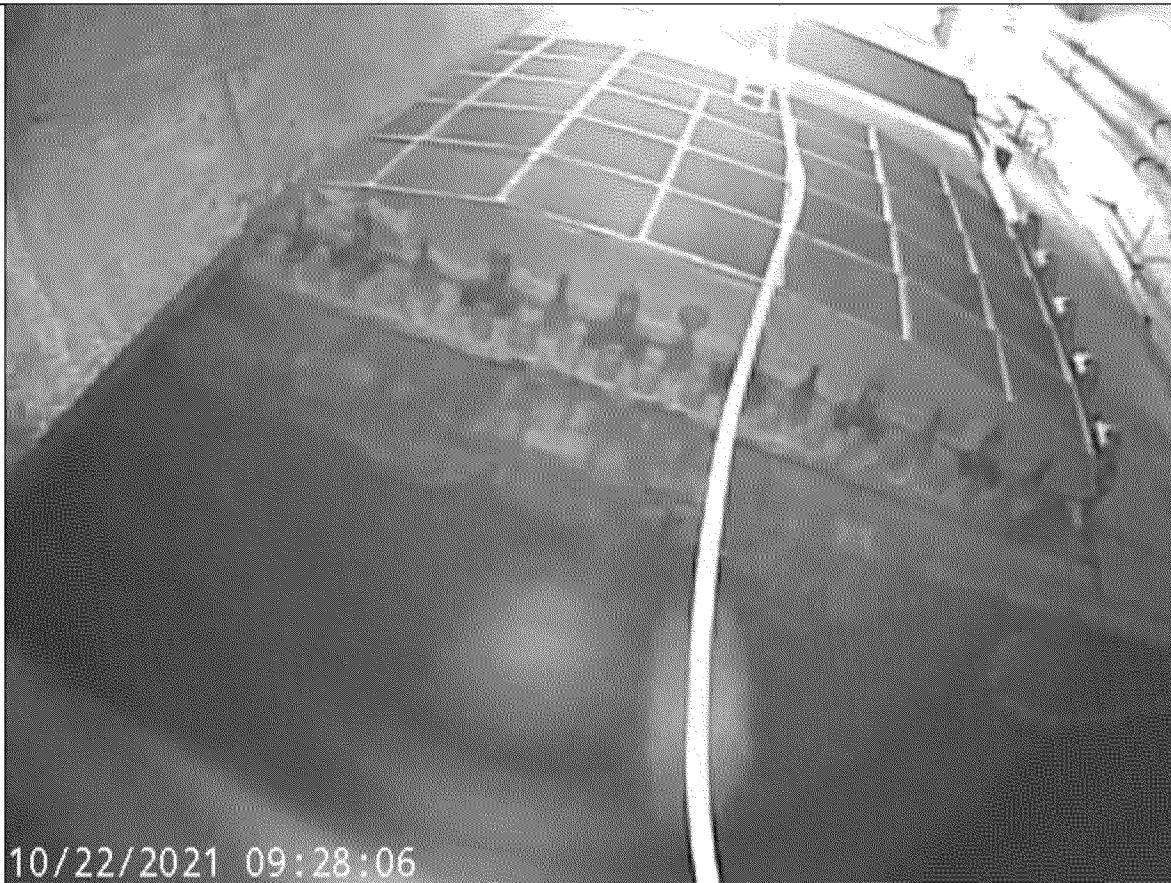
Photo #6 East diversion structure gate

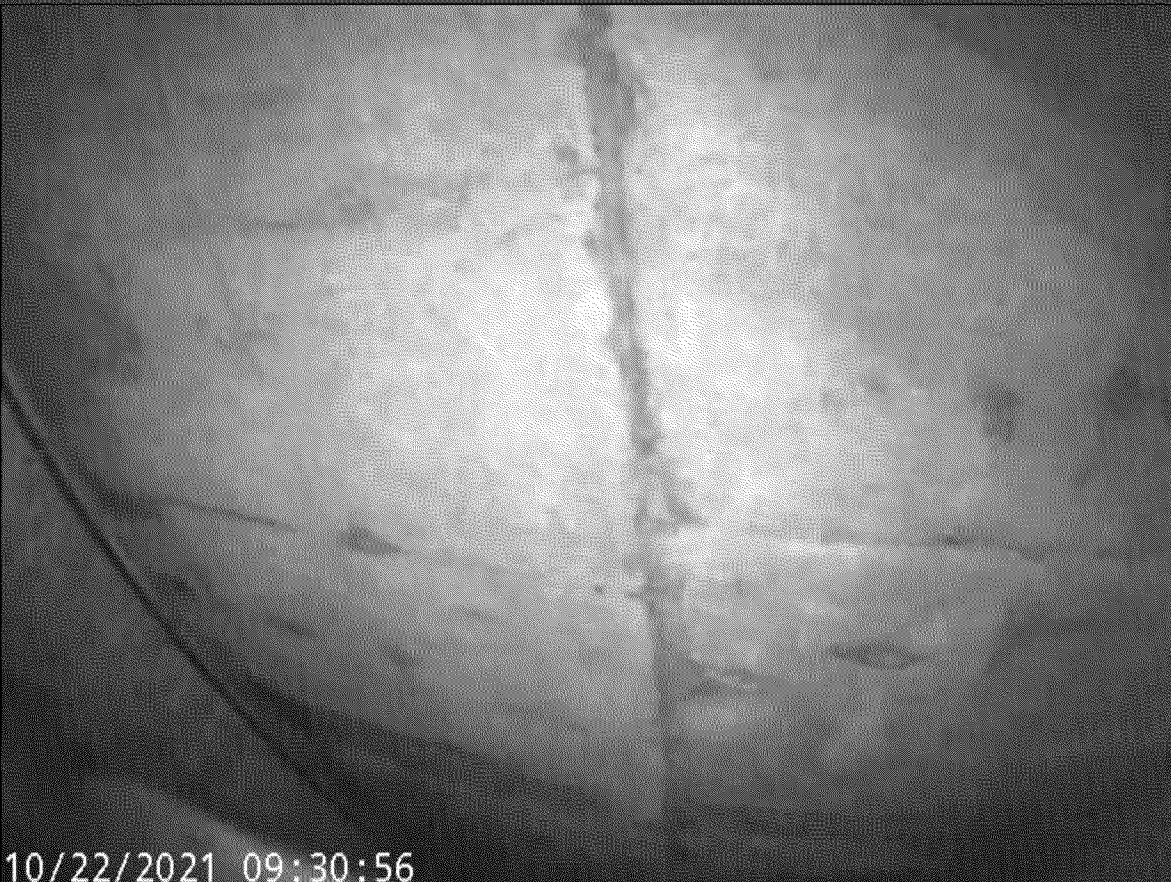
Photo #7: South wall and ceiling of tunnel between the east and west diversion structures

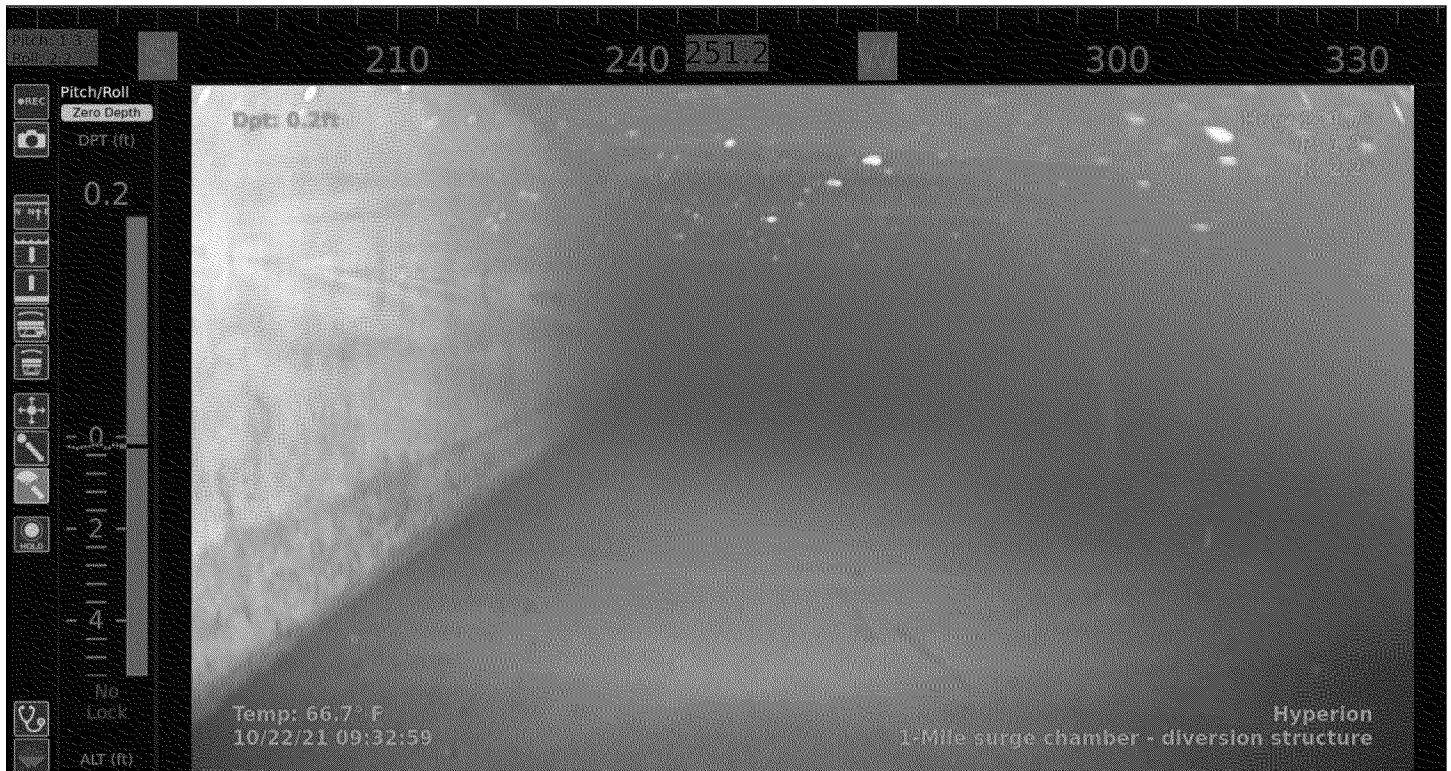
Photo #8: South wall and floor of tunnel between the east and west diversion structures

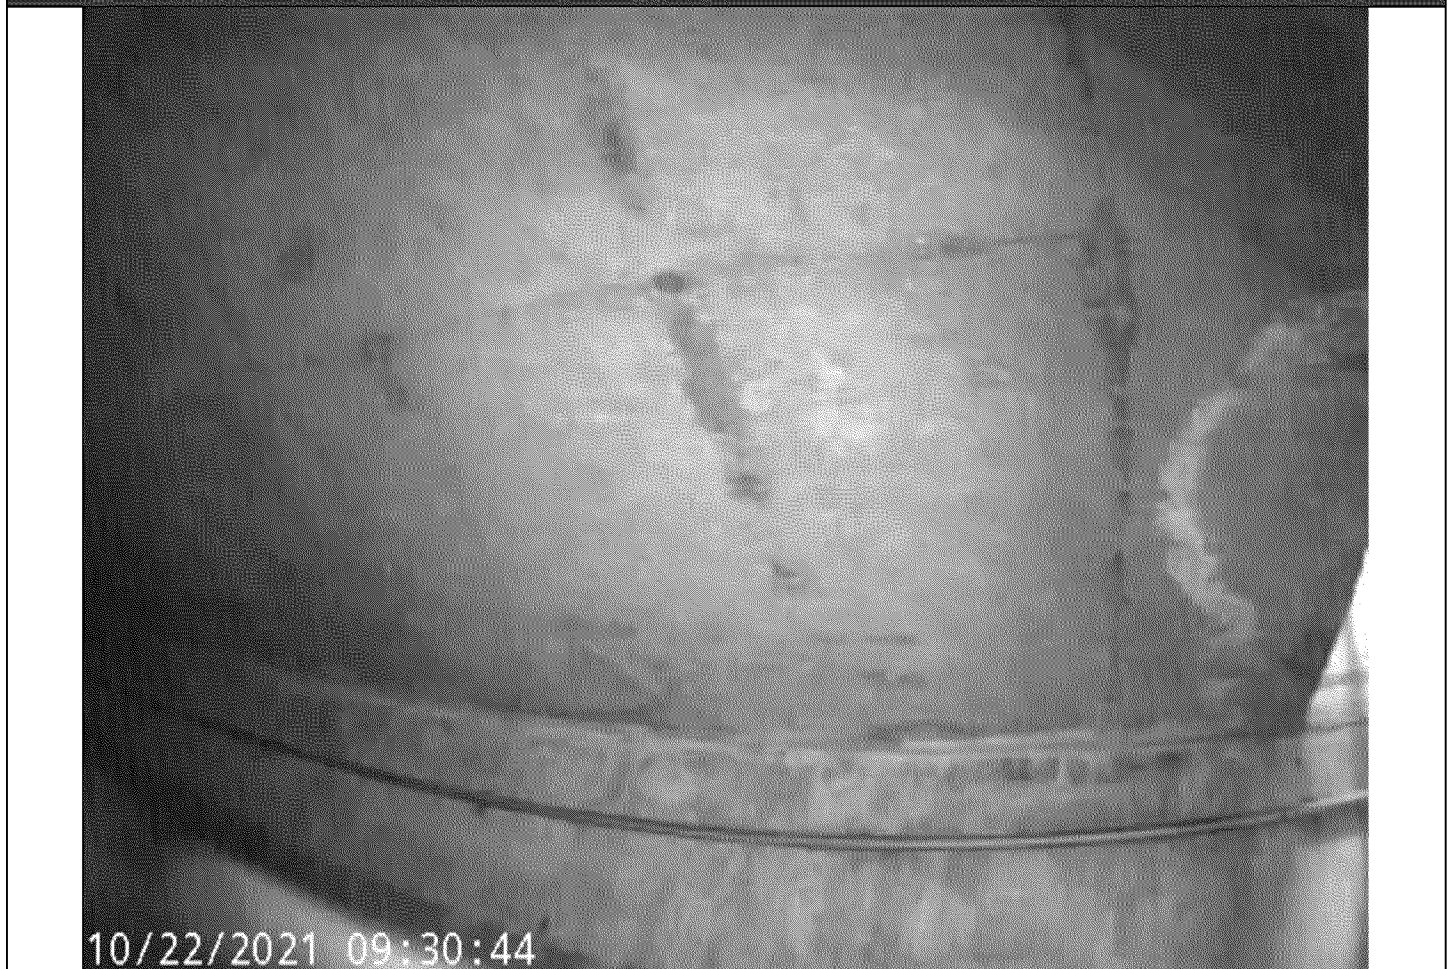
Photo #9: North wall and ceiling of tunnel between the east and west diversion structures

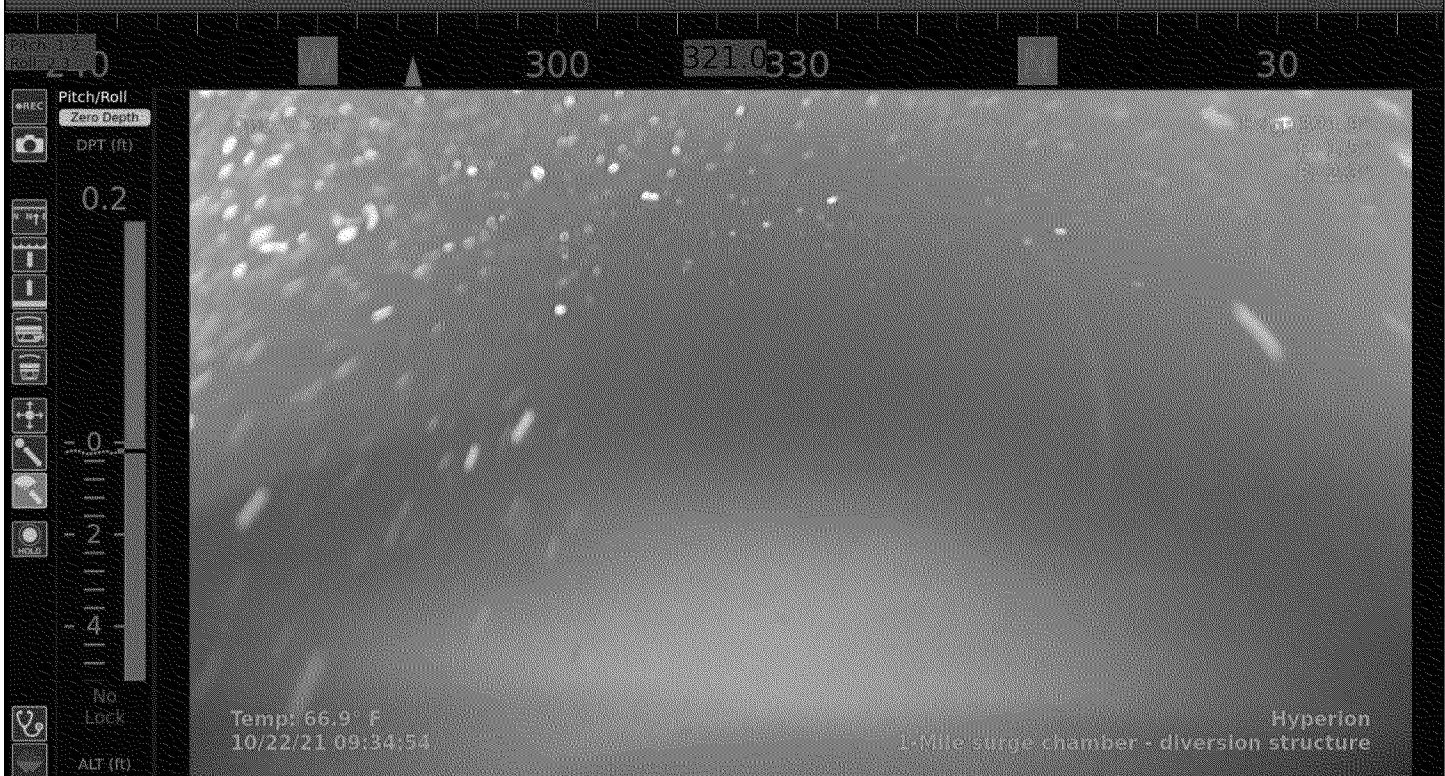
Photo #11: west wall and floor of the west diversion structure

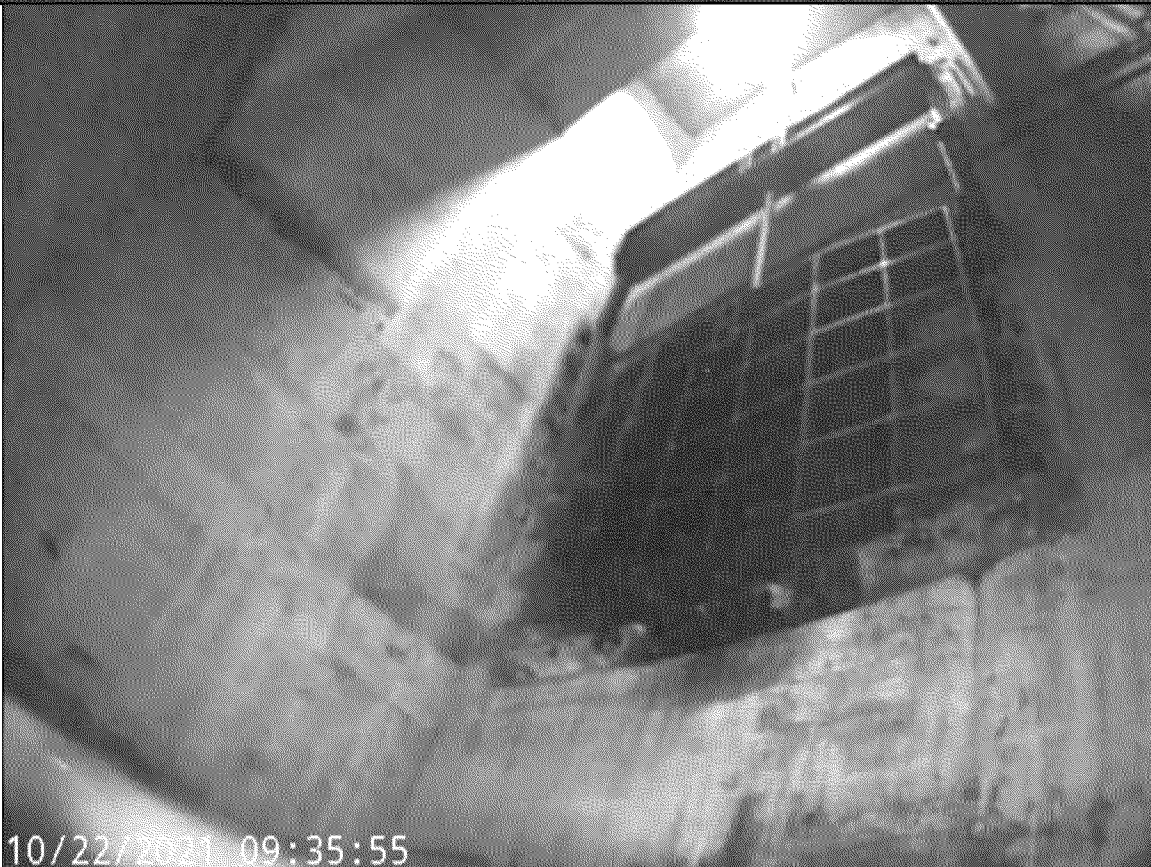
Photo #12: West diversion structure gate

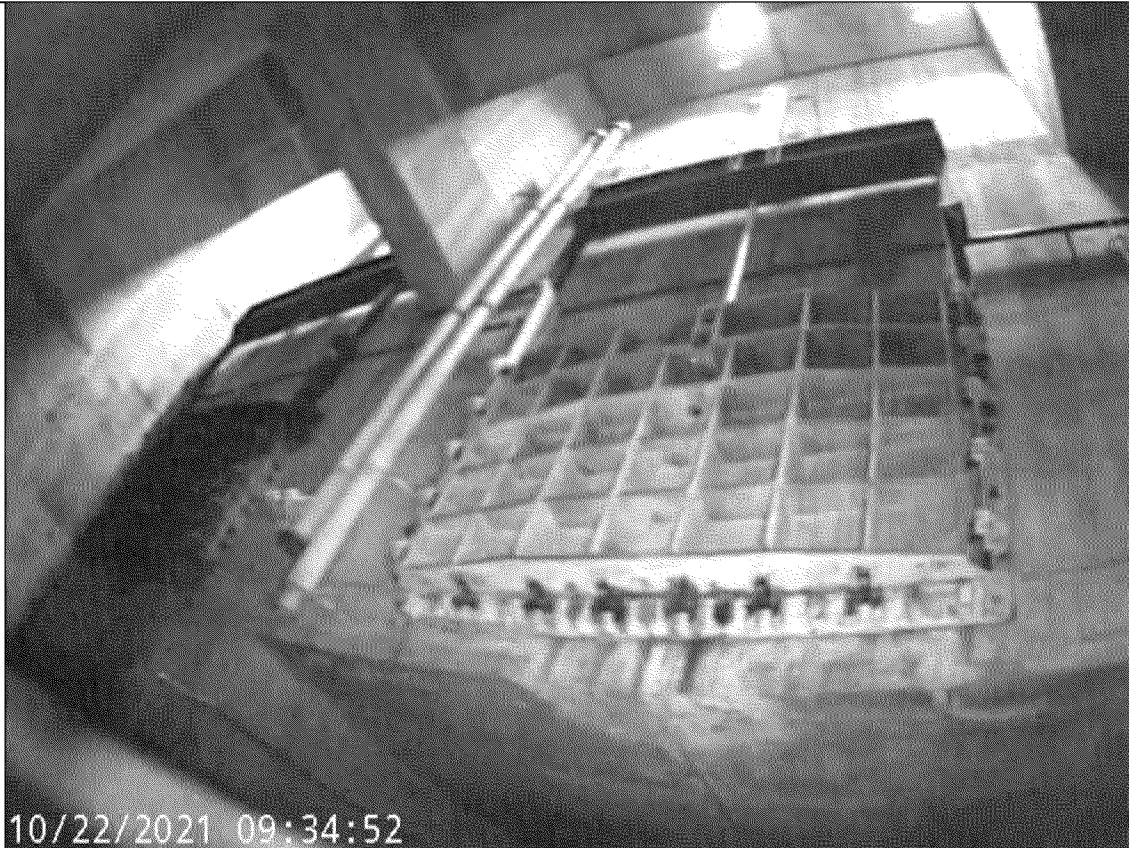
Photo #13: West diversion structure gate

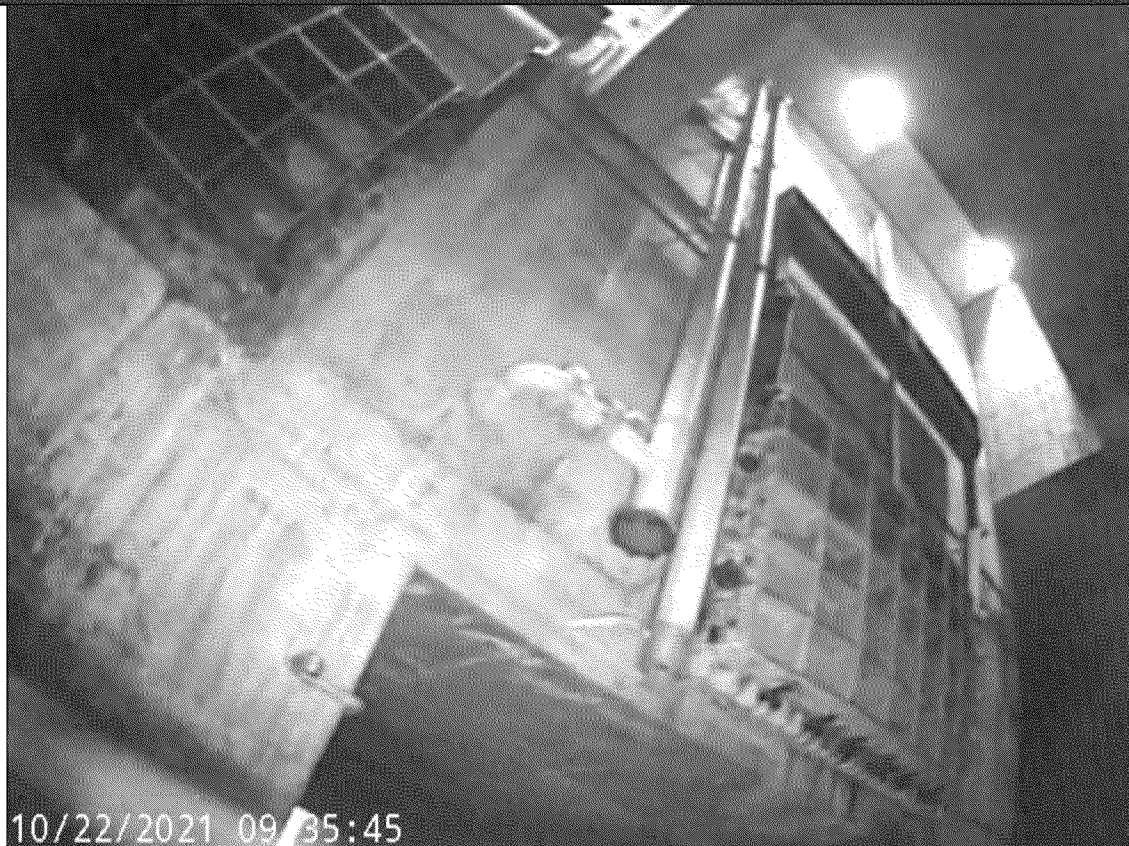
Photo #14: West diversion structure - piping between gates

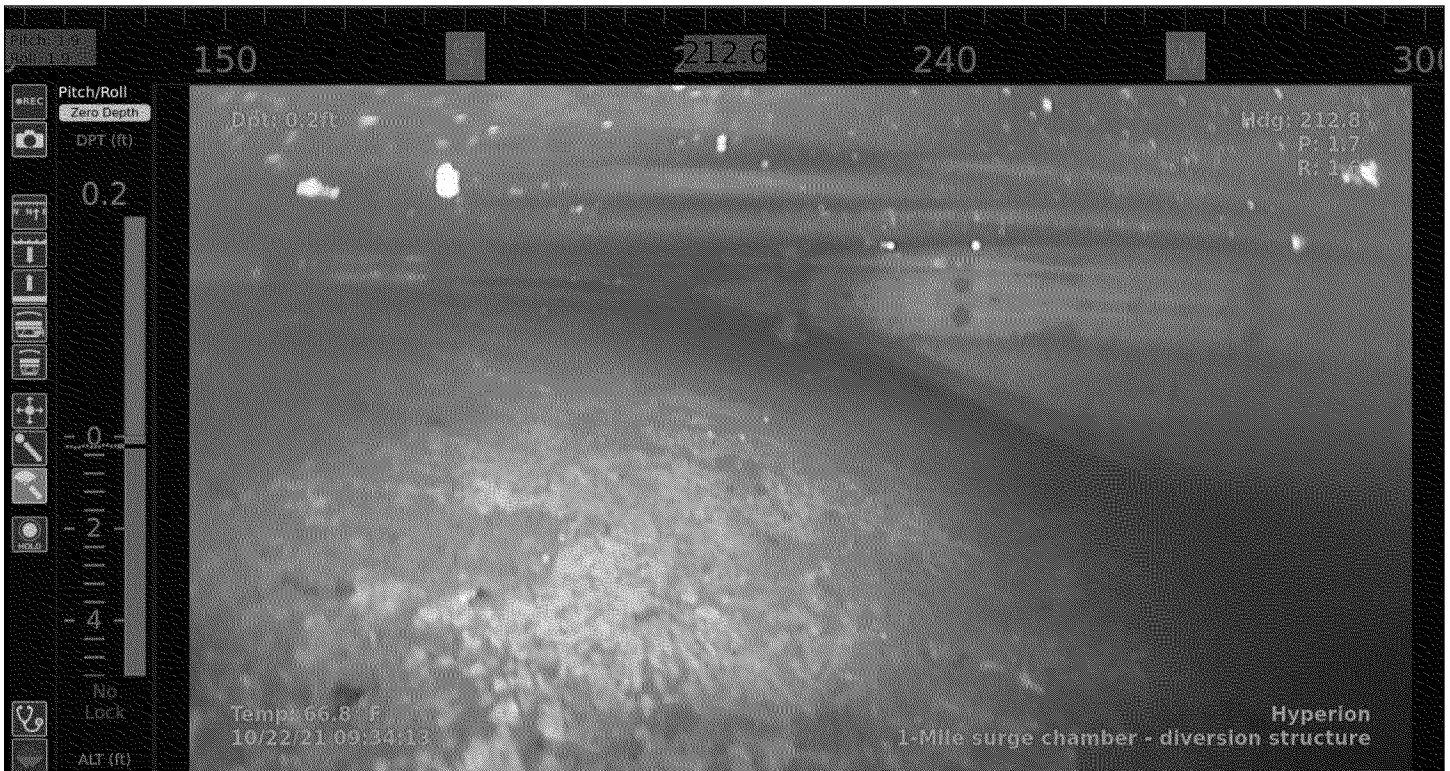
Photo #15: West diversion structure- floor ramping up towards surge tank

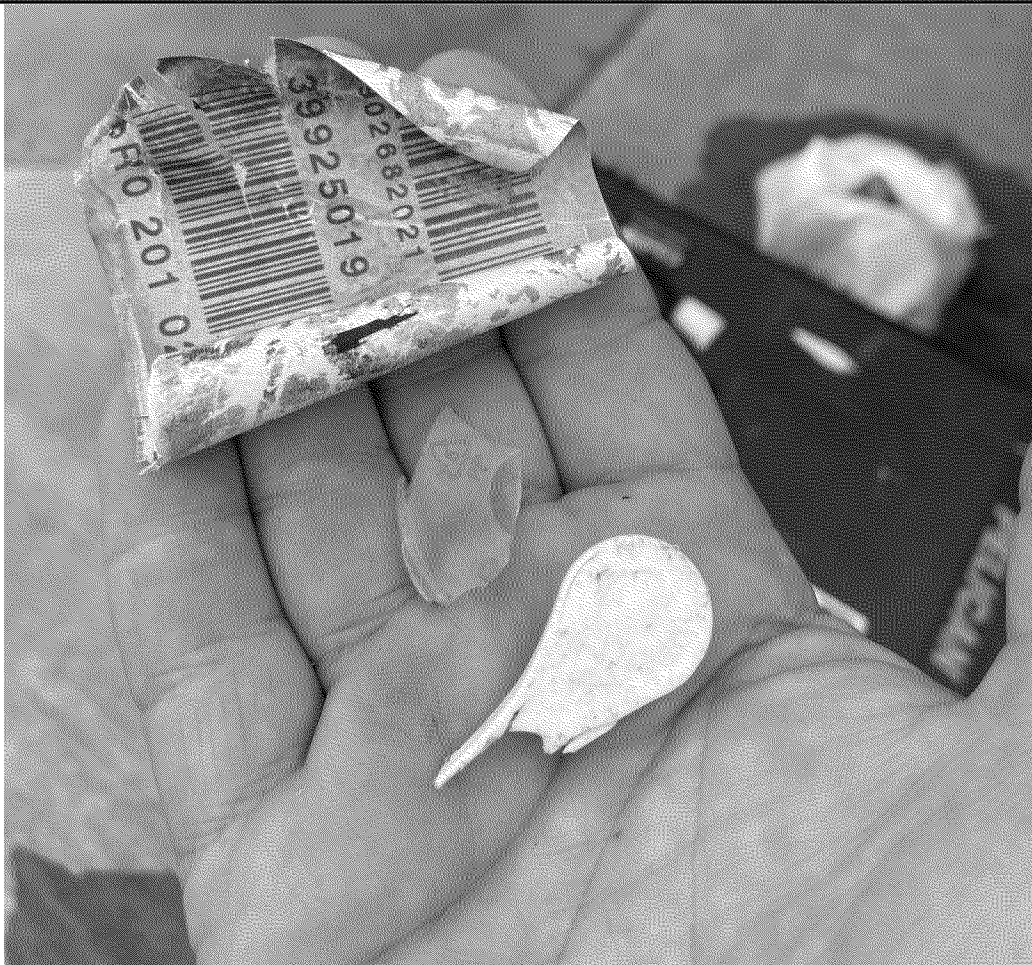
The diversion structures had some floating debris that appeared to be from storm drains nearby. In the photos and video files provided with this report a majority of what is seen floating in the water is broken up leaves/organic material and minor sediment. The ROV found and removed several small pieces of plastic.

Photo #16: Plastic debris removed from diversion structure

Based on the observed condition of the Diversion and Surge Chambers, Ballard Marine Construction recommends performing periodic inspections to ensure trash from storm drains are removed.
